SUMMARY REPORT ON POSSIBLE INFRACTIONS OBSERVED UNDER THE REGIONAL OBSERVER PROGRAMME

Prepared by IOTC Secretariat, 24 April 2018

In line with the requirement of IOTC Resolution 17/06 *On establishing a programme for transhipment by large-scale fishing vessels*, this document provides a summary of possible infractions against IOTC Resolutions by Large Scale Tuna Longline Vessels (LSTLVs) and carrier vessels, as recorded by observers deployed under the Programme during 2017.

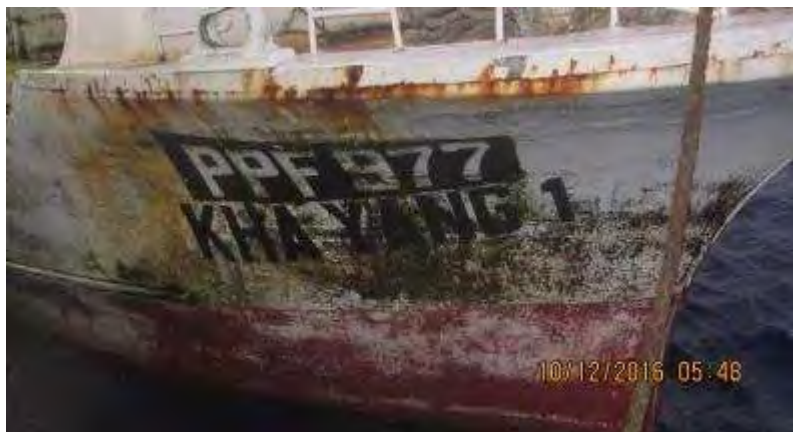
DEPLOY. NUMBER	VESSEL NAME	INSPECTION DATE	INSPECTION COMMENTS	DATE REPORT SENT TO CPC	CPC FEEDBACK
404/16	KHAYANG 1	From: 03/12/2016	The name on the bow was partially obscured by rust and was	23/01/2017	The marking on vessels was worn away due to strong waves and rough sea. The vessel

To: 15/12/2016	difficult to read (Error! Reference source not found.).	operator had repainted the vessels and markings.
--	-------------------	---	--

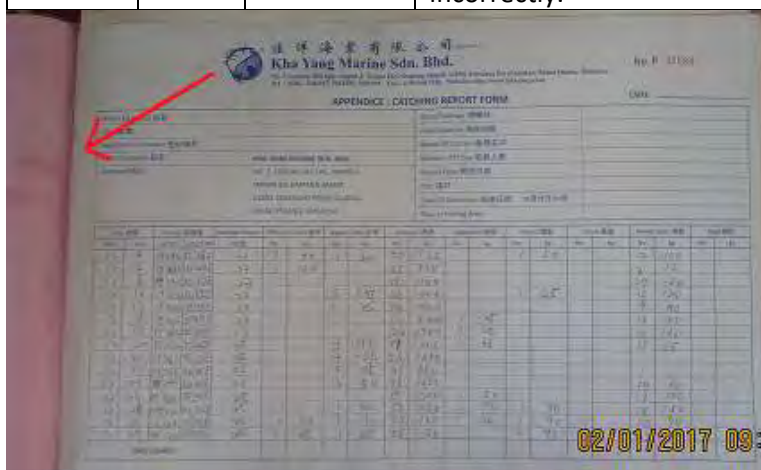
2. REPORT NUMBER 408/16

DEPLOY. NUMBER	VESSEL NAME	INSPECTION DATE	INSPECTION COMMENTS	DATE REPORT SENT TO CPC	CPC FEEDBACK
408/16	KHA YANG 3	From: 29/12/2016 To: 13/01/2017	KHA YANG 3. Missing logbook page# 30093. The observer was informed by the master of the LSTLV that that page was torn away by themselves because it was filled out incorrectly.	30/03/2017	The vessel operator had informed the Kha Yang 3 Captain to keep the logbook even if it was filled out incorrectly.
