RAPPORT DE SYNTHÈSE SUR LES INFRACTIONS PRÉSUMÉES CONSTATÉES AU TITRE DU PROGRAMME RÉGIONAL D'OBSERVATEURS

Rapport établi par le Secrétariat de la CTOI, le 24 avril 2017

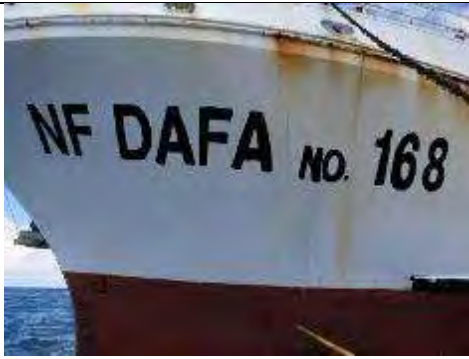
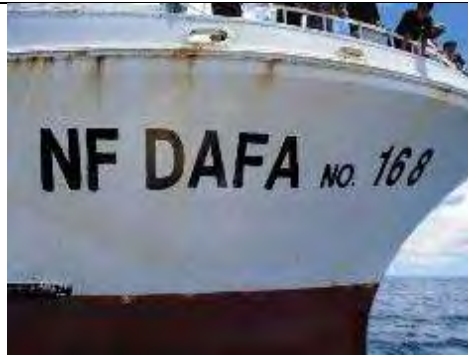
NEPTUNE No.1	Informed Captain to remove the Argos switch.
NEPTUNE NO.2	Informed Captain to remove the Argos switch.
NF DAFA NO.168	Markings repainted. Please refer to picture attached.

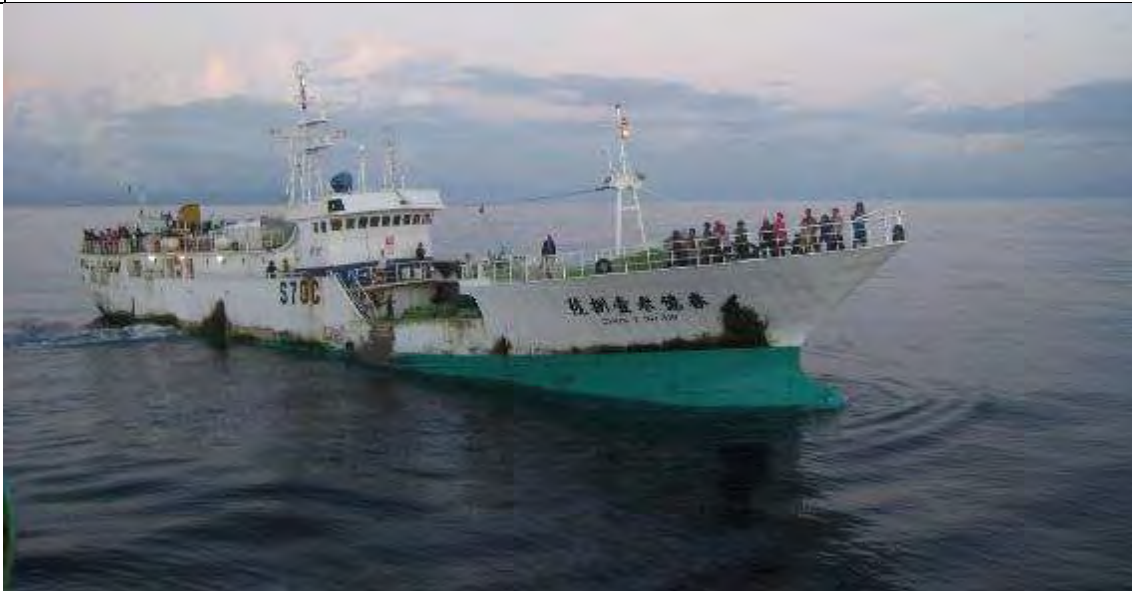
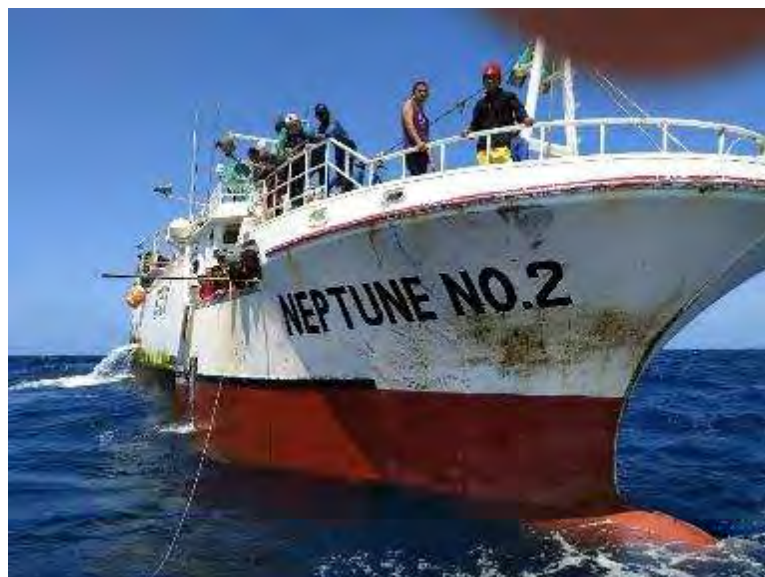
Neptune No. 2	Informed Captain, markings will be corrected when possible / next port visit to Port Victoria
Chun I No.318	Markings repainted. Please refer to picture attached.

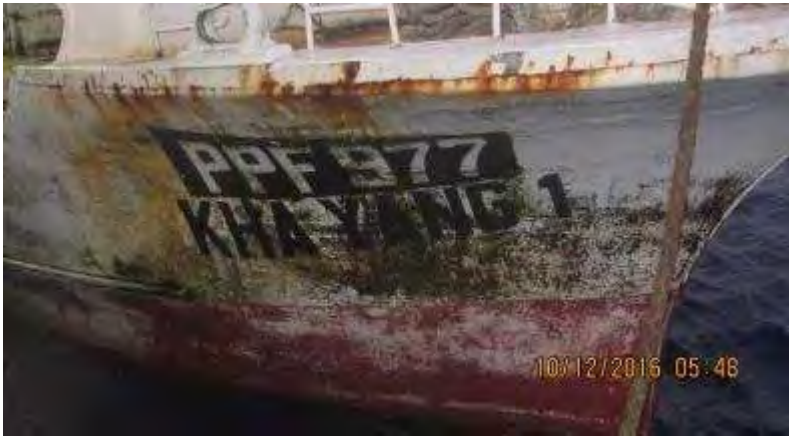
DEPLOY. NUMBER	VESSEL NAME	INSPECTION DATE	INSPECTION COMMENTS	DATE REPORT SENT TO CPC	CPC FEEDBACK
404/16	KHAYANG 1	From: 03/12/2016	The name on the bow was partially obscured by rust and was	23/01/2017	The marking on vessels was worn away due to strong waves and rough sea. The vessel

To: 15/12/2016	difficult to read (Error! Reference source not found.).	operator had repainted the vessels and markings.
--	-------------------	---	--

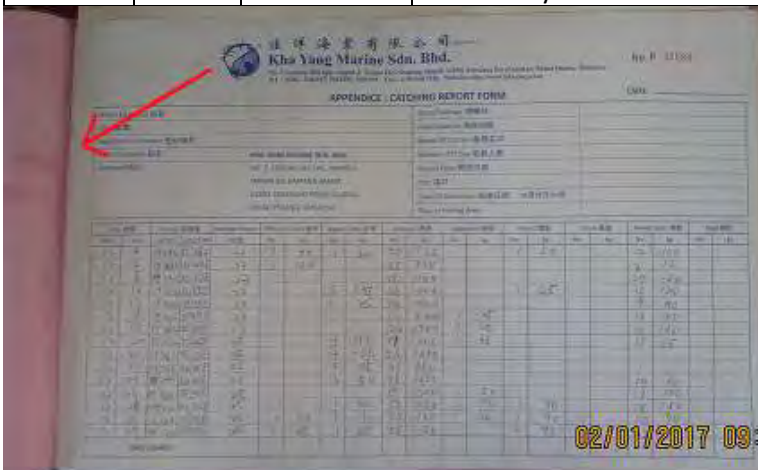
2. REPORT NUMBER 408/16

DEPLOY. NUMBER	VESSEL NAME	INSPECTION DATE	INSPECTION COMMENTS	DATE REPORT SENT TO CPC	CPC FEEDBACK
408/16	KHA YANG 3	From: 29/12/2016 To: 13/01/2017	KHA YANG 3. Missing logbook page# 30093. The observer was informed by the master of the LSTLV that that page was torn away by themselves because it was filled out incorrectly.	30/03/2017	The vessel operator had informed the Kha Yang 3 Captain to keep the logbook even if it was filled out incorrectly.

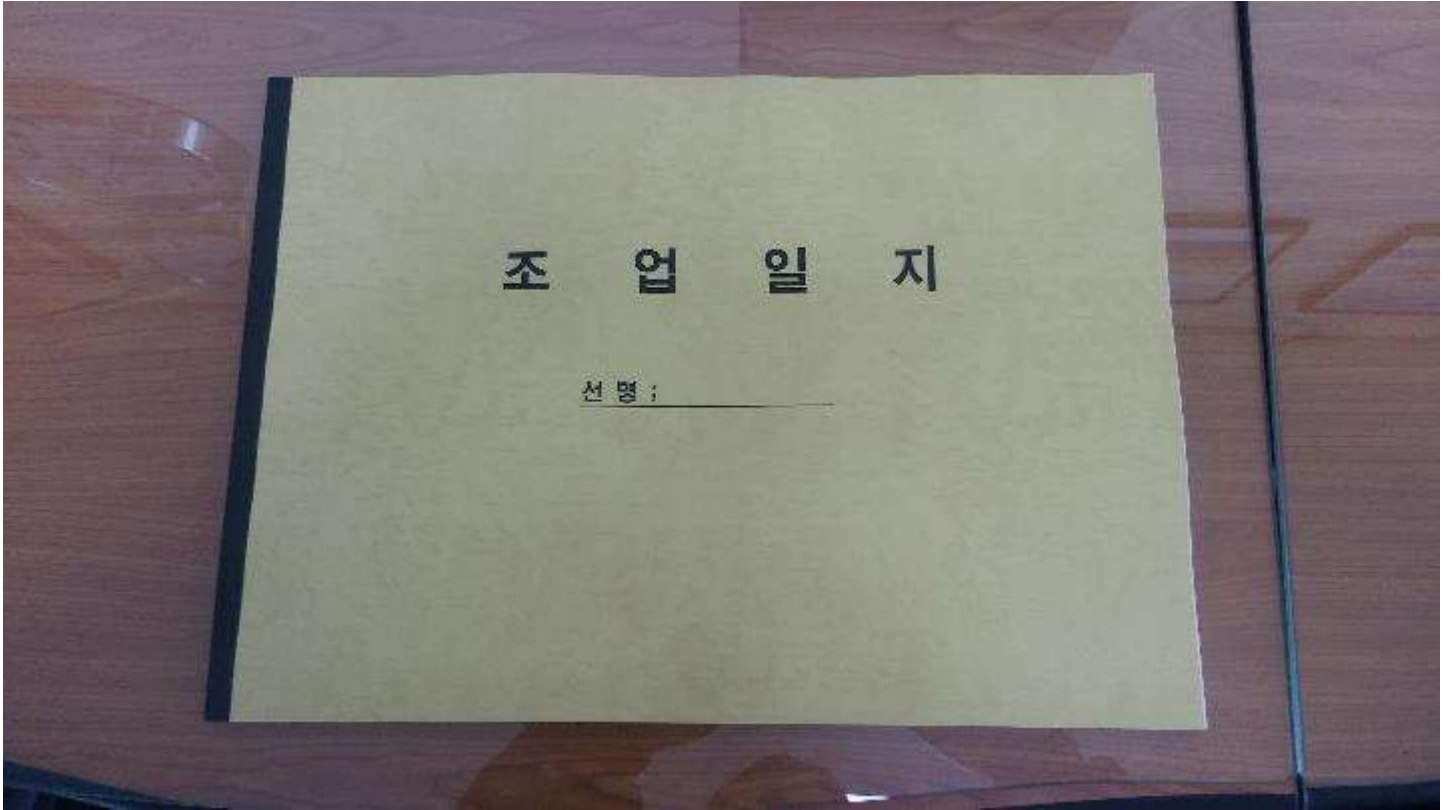
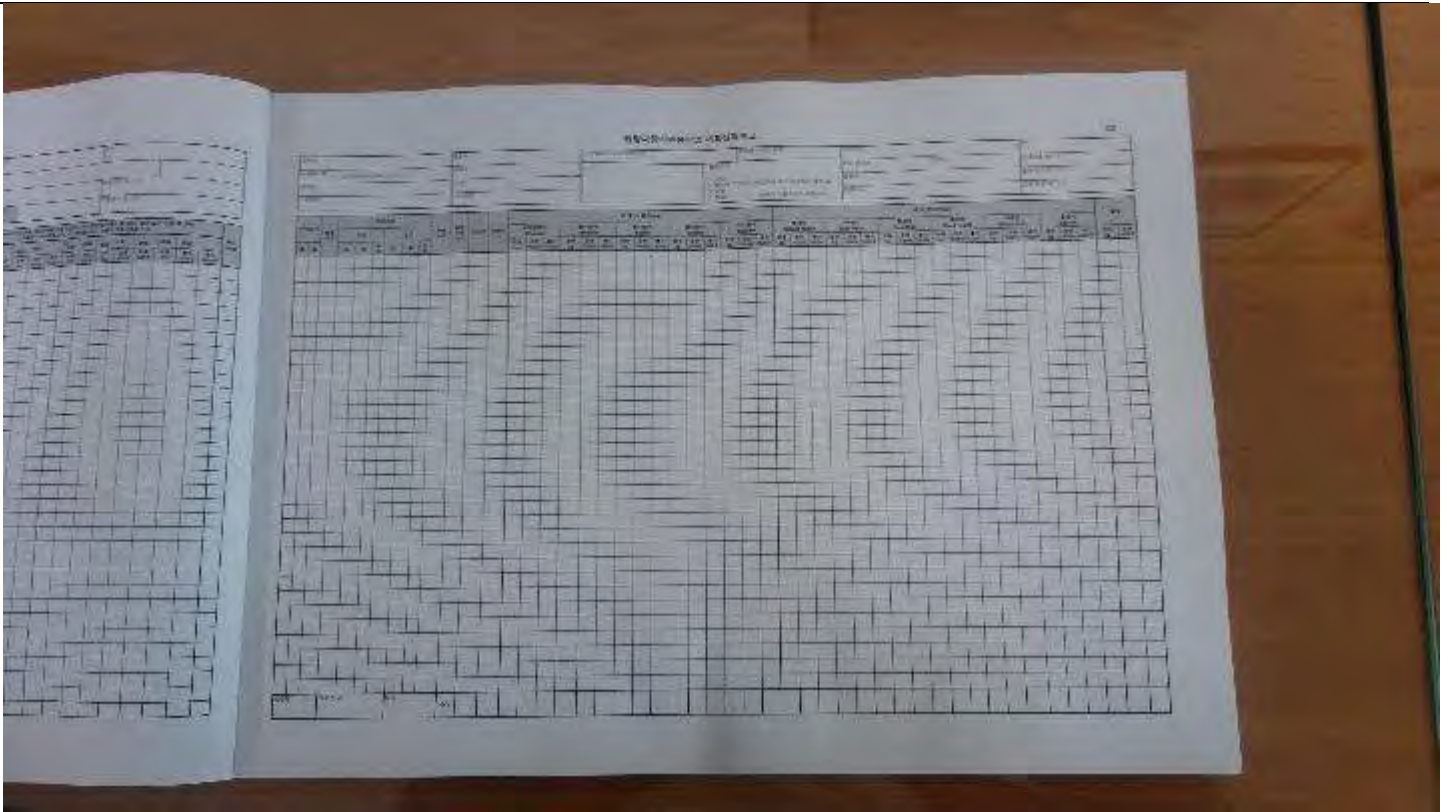
10	448	No. 77 HAE CHEON	07/09/17	The vessels logbook was unbound, the pages were stapled together	Completed the replacement of replacing log book with bound, numbered log book in 20 March, 2018. Pictures shall be attached.
----	-----	---------------------	----------	--	---
